## Inspection Report Muayene Raporu

Report / Rapor No : 25-IS-0083-34-T-001

**Project Name**  
Projenin Adı : Subor Biaxial SSB Design Test

## 1.1. DN700 PN10 SN10000 Glassfiber Reinforced Polyester Pipe - Biaxial SSB Design

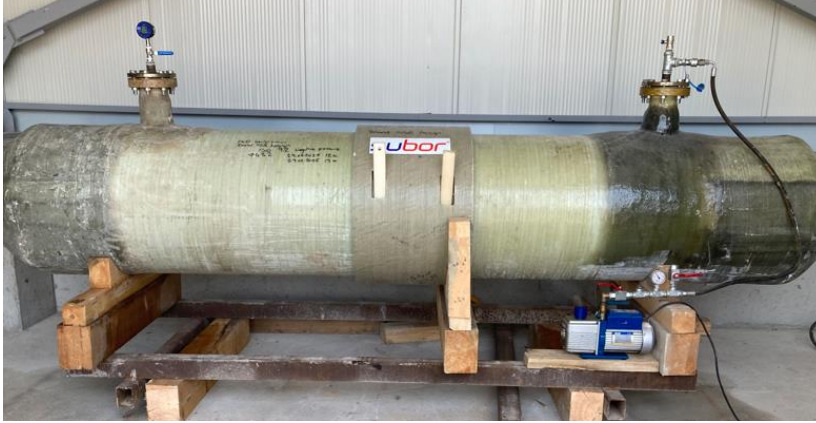
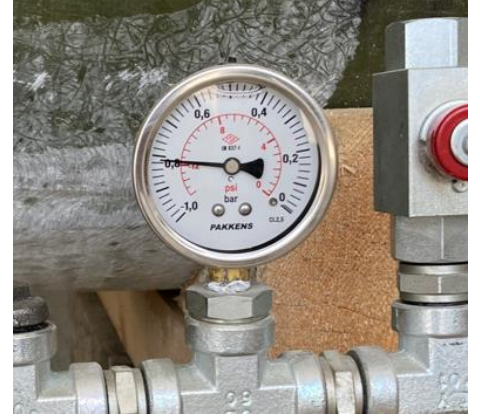
| Activity No<br>Aktivite No | Notes / Notlar | Reference<br>Referans |
|---|---|---|
| 3.1 | ISO 7432 Clause 9.2 Negative pressure | Photos (1) |

| | <p>For the Negative Pressure the vacuum inside was created by an external pump connected to the pipe. A negative pressure of at least -0,8 bar was applied for 1 hour. Then the pressure was returned to atmospheric pressure.</p> <p>No pressure increase, leakage or damage was detected.</p> | |

Photos 1 : Negative pressure test

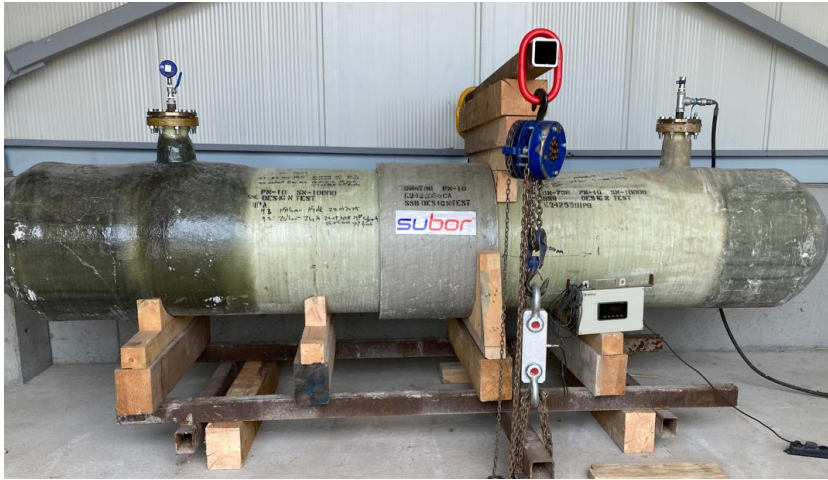
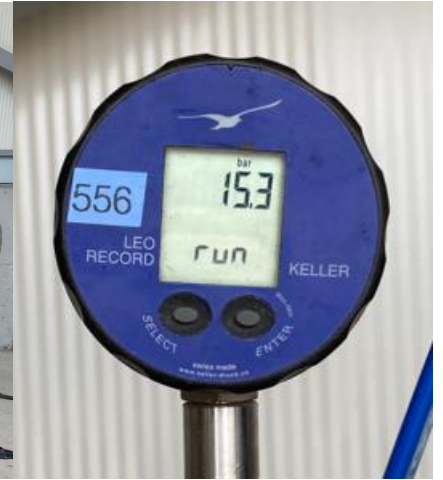
| 3.2 | <p><b>ISO 7432 Clause 9.3 &amp; 9.4 Deformation with internal / cyclic pressure and end thrust</b></p> <p>A load of 1.560 kg (deformation force F) has been applied near the coupling.<br/> <b>Initial pressure:</b> The test specimen was filled with water and pressurized up to min.15 bar and hold for 15 minutes.<br/> <b>Positive Static pressure:</b> The test specimen was filled with water and pressurized up to min.20 bar and hold for 24 hours.</p> <p>A load of 1.680 kg (deformation force F) has been applied near the coupling.<br/> <b>Positive cyclic pressure:</b> The test specimen was pressurized from 0 to 15 bar in a period of 1,5 min. to 3 minutes. The pressure was reduced to atmospheric pressure and then raised again up to 15 bar. This cycle has been repeated for 10 times.</p> <p>No pressure drop, leakage or damage was detected.</p> | Photos (2) |

Photos 2 : Deformation with internal / cyclic pressure and end thrust

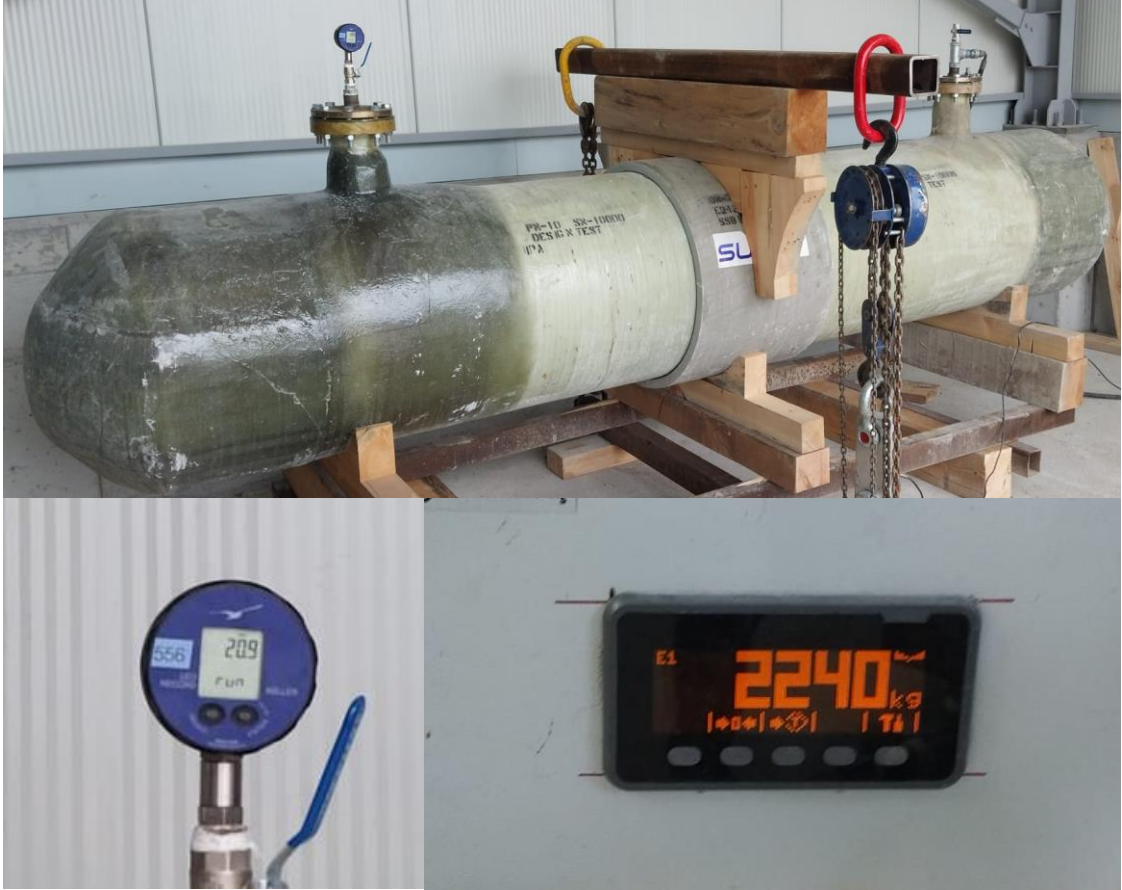
| 3.3 | <p><b>ISO 7432 Clause 9.5 Method A Resistance to bending with pressure and end thrust</b></p> <p>A load of 4.480 kg (deformation force F) has been applied on the coupling.</p> <p><b>Initial pressure:</b> The test specimen was filled with water and pressurized up to min.15 bar and hold for 15 minutes.</p> <p><b>Positive Static pressure:</b> The test specimen was filled with water and pressurized up to min.20 bar and hold for 24 hours.</p> <p>No pressure drop, leakage or damage was detected.</p> | Photos (3) |

Photos 3 : Method A Resistance to bending with pressure and end thrust

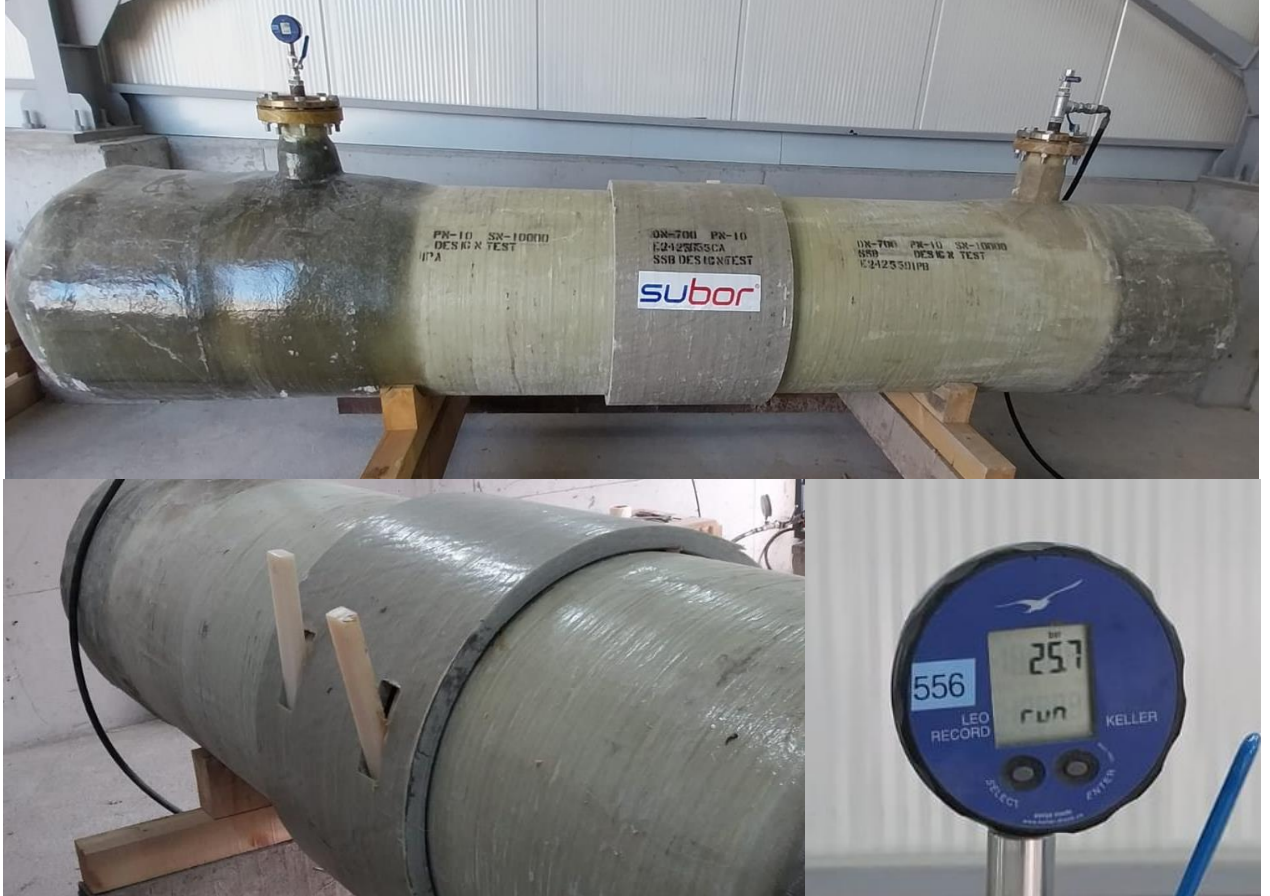
| 3.4 | <p><b>ISO 7432 Clause 9.6 Resistance to maintained internal pressure and end thrust</b></p> <p><b>Positive static pressure, durability test:</b> The test specimen was filled with water and pressurized up to min.25 bar and hold for 100 hours.</p> <p>No pressure drop, leakage or damage was detected.</p> | Photos (4) |

Photos 4 : Resistance to maintained internal pressure and end thrust

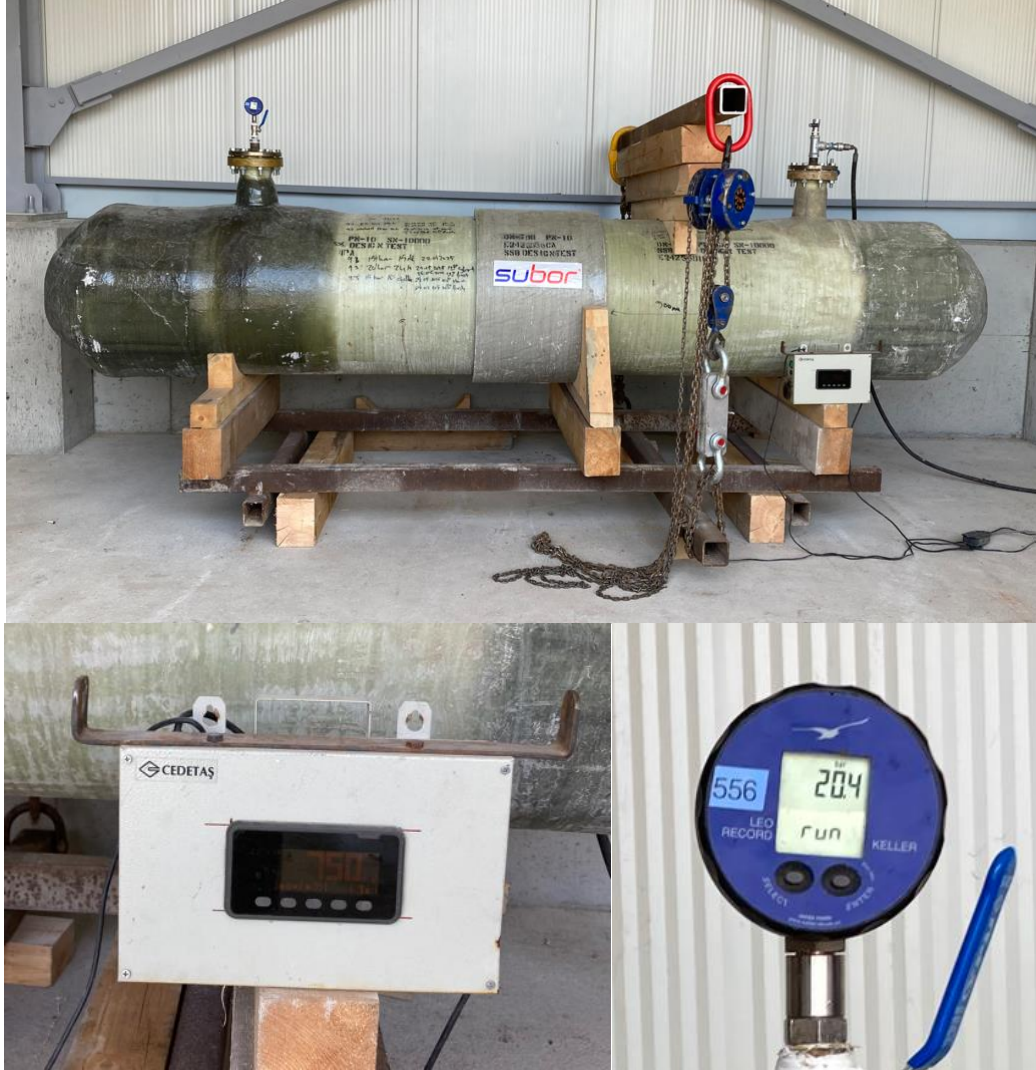
| 3.5 | <p><b>ASTM D4161 Clause 7.3 Hydrostatic Test in Shear Loading Position</b></p> <p>A load of 1.400 kg (deformation force F) has been applied near the coupling with a distance of 300 mm and the test specimen was pressurized up to min.20 bar and hold for 10 minutes.</p> <p>No pressure drop, leakage or damage was detected.</p> | |

Photos 5 : Hydrostatic Test in Shear Loading Position

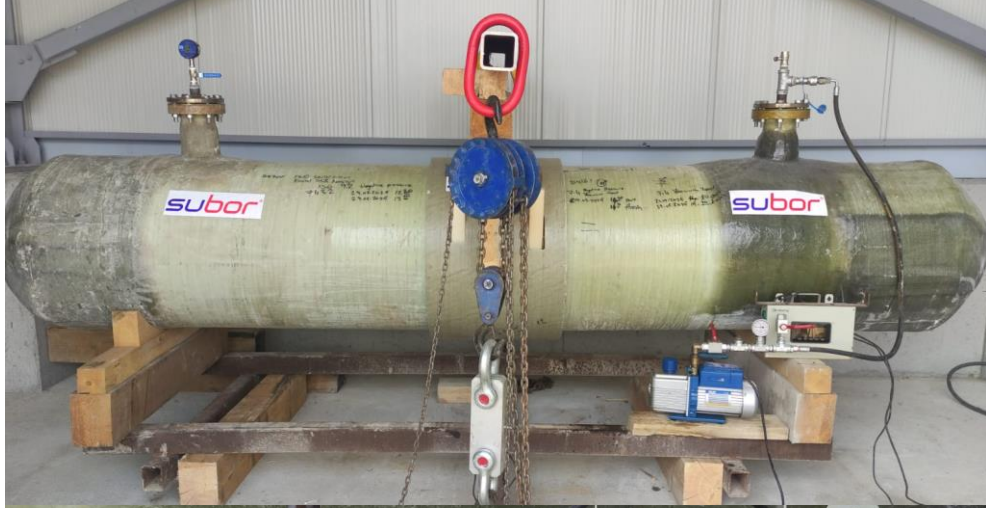
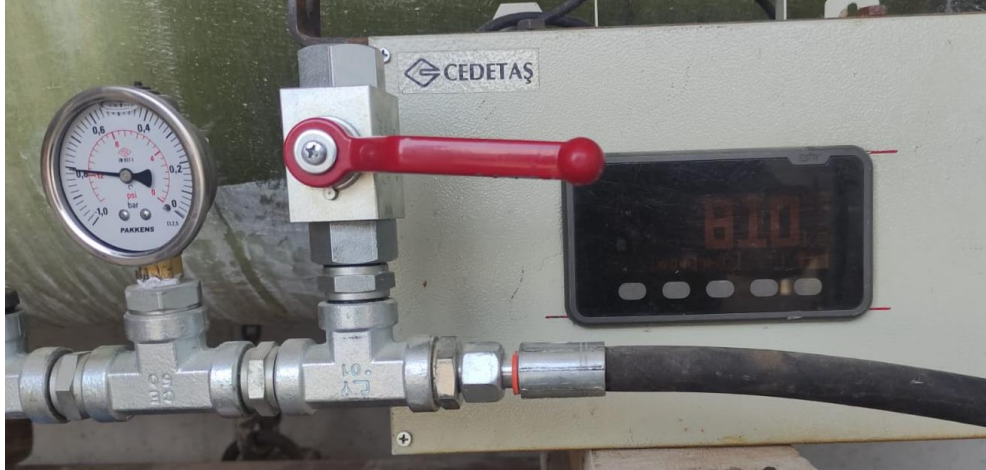
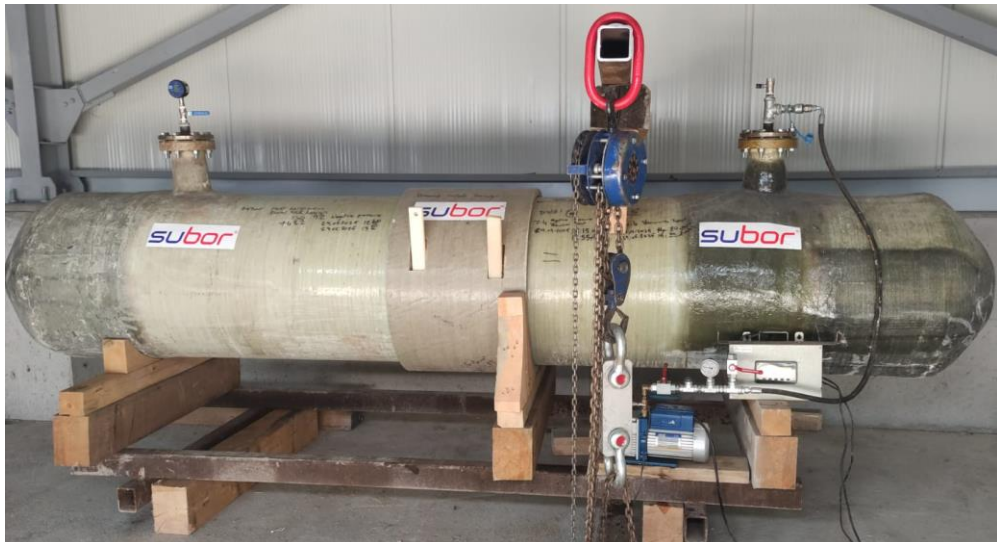
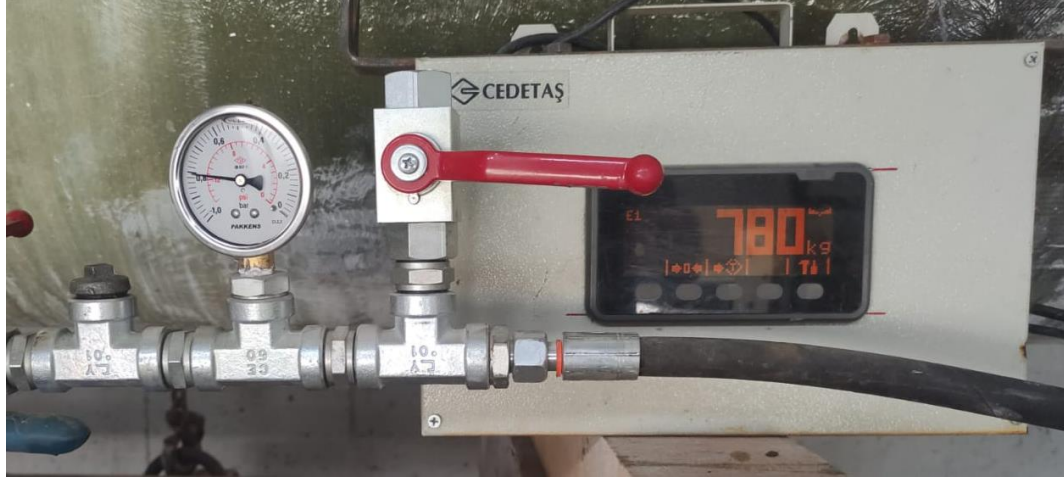
| 3.6 | <p><b>ASTM D4161 Clause 7.4 External Pressure Test</b></p> | Photos (5) |

| | <p>A load of 1.620 kg (deformation force F) has been applied on the coupling and a negative pressure of at least -0,8 bar was applied for 40 min.</p> <p>A load of 1.560 kg (deformation force F) has been applied near (distance of 300 mm) the coupling and a negative pressure of at least -0,8 bar was applied for 40 min.</p> <p>No pressure increase, leakage or damage was detected.</p> | |

Photos 6 : External Pressure Test
